**Flood Control Project Maintenance
Levee Inspections**

Fall 2009 Levee Maintenance Deficiency Summary Report

Reclamation District No. 0755 Randall

Levee Inspection Report By Mile - Fall 2009

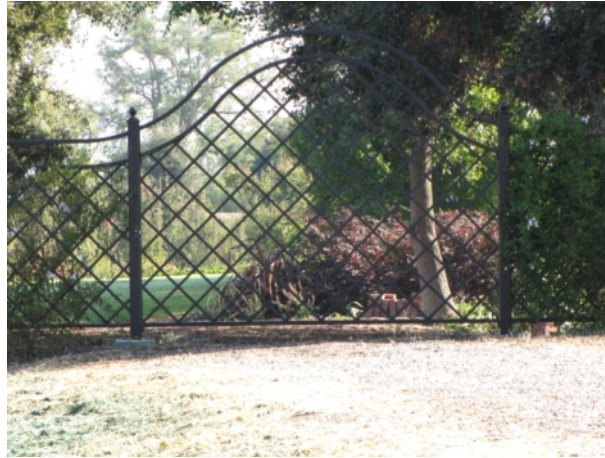
phillips_20091215_26.jpg

Levee Mile Report Line	1
Start Levee Mile	0.02
End Levee Mile	0.02
Location	Land Side
Category	Earthen Levee
Item	Encroachments

This is the gate Mr. Hemley has installed without a Permit.

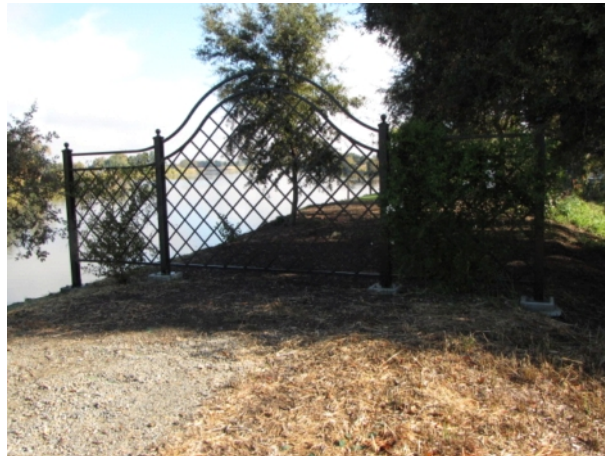
phillips_20091215_27.jpg

Levee Mile Report Line	1
Start Levee Mile	0.02
End Levee Mile	0.02
Location	Land Side
Category	Earthen Levee
Item	Encroachments

Hemley's gate
